Sample Inspection Report

Five Star Property Inspections, Inc.
Phone: 949/290-2086 Fax: 949/496-4485
Email: info@fivestarinspections.com
www.fivestarinspections.com

101 FILE/DATE/TIME	File #60503 Date: 6/5/2004 Time: 9:00 AM.
102 CLIENT NAME	Mr & Mrs. Home Buyer.
103 LOCATION	105 Springview Ave Orange County, CA. 92677.

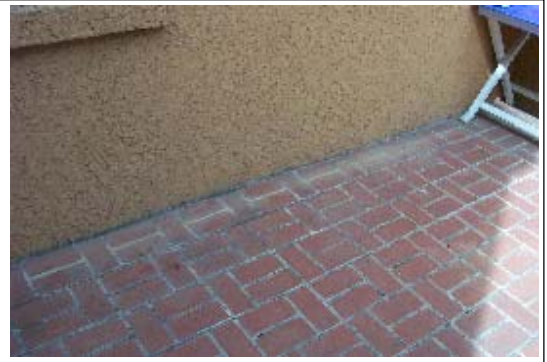
348 PATIO(S)

The patio appeared functional, with exceptions noted.
a. [FE] The patio surface was above the weep screed at the bottom edge of the stucco wall. This condition is conducive to moisture intrusion and deterioration of the wall. We recommend a full evaluation and/or corrections by a specialist in the appropriate trade.

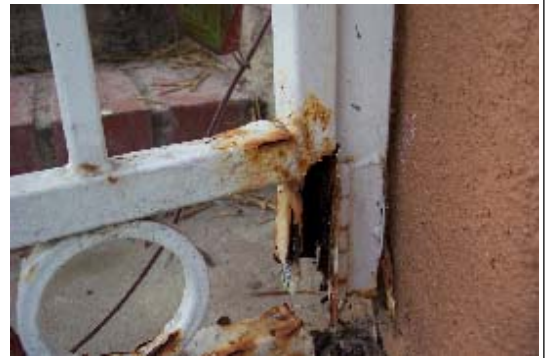
353 FENCING & GATE(S)

The yard fencing appeared functional, with exceptions noted.
a. [CR] The gate(s) were damaged/deteriorating. We recommend correcting the condition(s) noted.

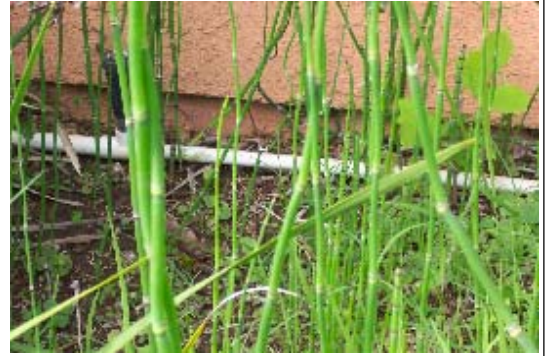
370 VISIBLE PIPING

a. [CR] The exposed/unpainted sprinkler pipes will deteriorate from exposure to the UV rays from sunlight. We recommend correcting the condition(s) noted.

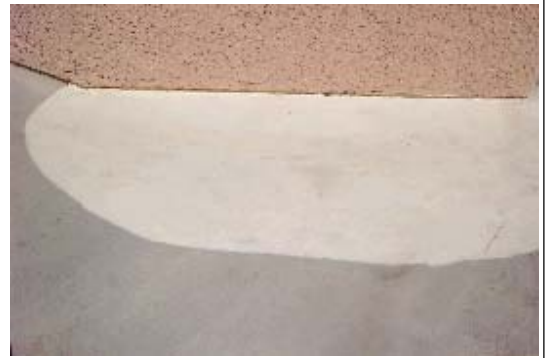
414 BUILT-UP ROOFING

a. [FE] The roof had advanced deterioration and damaged areas. These conditions are conducive to leakage. We recommend a full evaluation and/or corrections by a specialist in the appropriate trade.

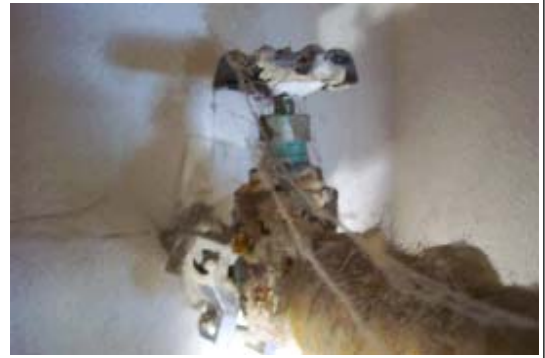
708 SUPPLY PIPING

The shutoff valve and visible water supply connectors appeared functional and were insulated to minimize heat loss, with exceptions noted.
 a. [NOTE] The shutoff valve was corroded, no leakage noted.

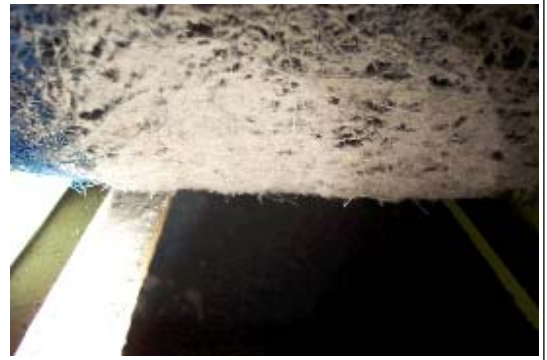
915 BLOWER / FILTER(S)

The blower and filter appeared functional, with exceptions noted.
 a. [CR] The blower and filter were dirty. These conditions restrict the air flow and reduce the system's efficiency. We recommend having the system cleaned and serviced by a specialist in the appropriate trade.

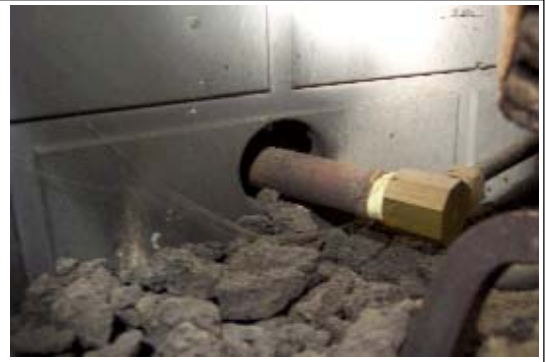
The fireplace and visible areas of the flue appeared functional, with exceptions noted.

a. [SC] The gas line was not sealed at the wall where it entered the firebox. We recommend sealing the gap around the pipe to the firebox wall.

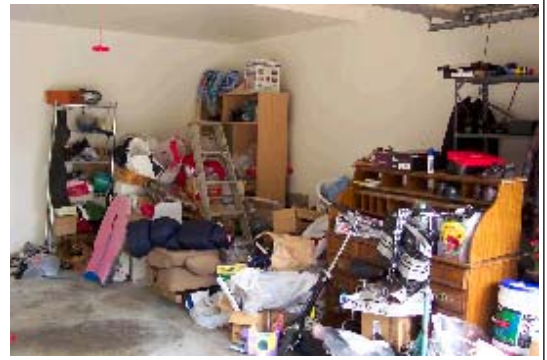
1514 INTERIOR WALL(S)

The visible areas of the walls and ceiling appeared functional, with exceptions noted.
a. [CR] Portions of the interior walls and floors were not visible at this time due to stored personal items. We recommend checking these areas after the items have been removed.

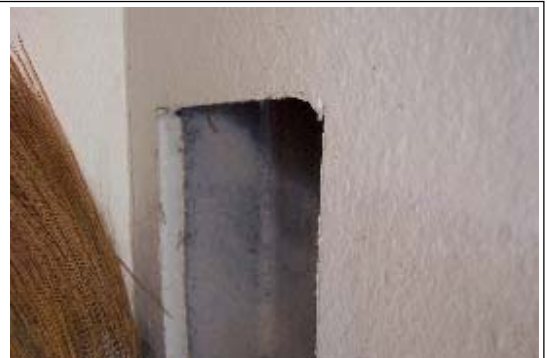
1518 FIRE WALL(S)

The visible areas of the garage firewall/ceiling appeared functional, with exceptions noted.
a. [SC] There were holes noted in the fire-resistive wall(s) between the garage and living space. We recommend correcting the condition(s) noted.

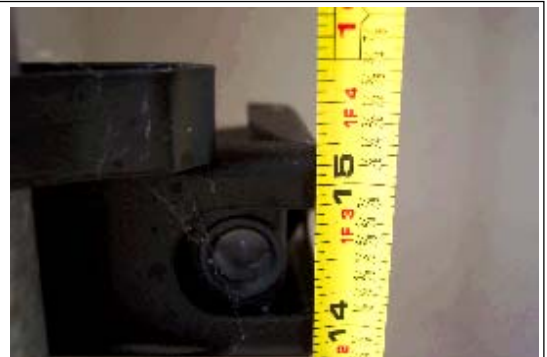
1521 DOOR OPENERS

The automatic car door opener(s) were functional, with exceptions noted.
a. [SC] The secondary safety system (electric eyes) were mounted higher than the manufacturer's recommendation of 4" to 6" above the floor. We recommend correcting the condition(s) noted.
